## TEST REPORT

| <p align="center"><b>Report Number</b><br/><b>ORT251224112703-R02Rev1</b></p> | | | | | |
| <b>Sample Name:</b> | <b>Automotive streaming media Mirror、DVR-MIR012、DVR-MIR012-BO</b> | | <b>Applicant:</b> | <b>WATEX CO.,LTD.</b> | |
| <b>Test Item:</b> | <b>Impact test</b> | | | | |

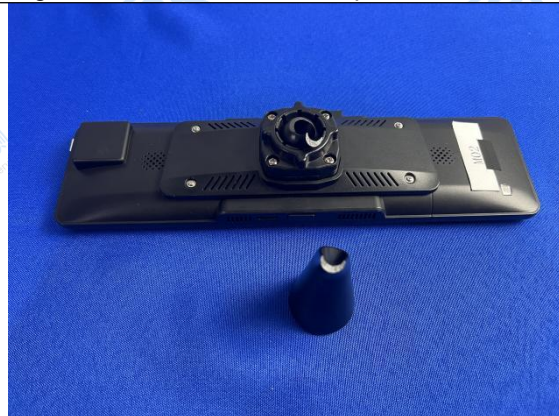
Fig.7 Appearance inspection after test (The  
45-degree impact bracket has fractured.)

| Sample No. | Inspection after test | Conclusion |
|---|---|---|
| ORT251224112703-SS2/16 | <p>1.Frontal Impact:Impact on the support resulted in fracture.</p> <p>2.45° angle Impact:Impact on the support resulted in fracture.</p> <p>The test shall be considered satisfactory if the reflecting surface is made of safety glass and if, in the event of breakage, the fragments remain adherent to the housing or to a surface firmly fixed to it.</p> <p>Partial separation of the glass is acceptable provided that the separation between the edges of any crack does not exceed 2.5 mm.</p> <p>Detachment of small splinters at the point of impact is permitted.</p> | PASS |

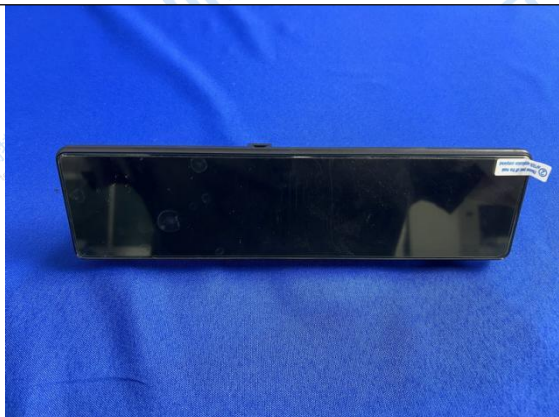
Fig.8 Appearance inspection after test

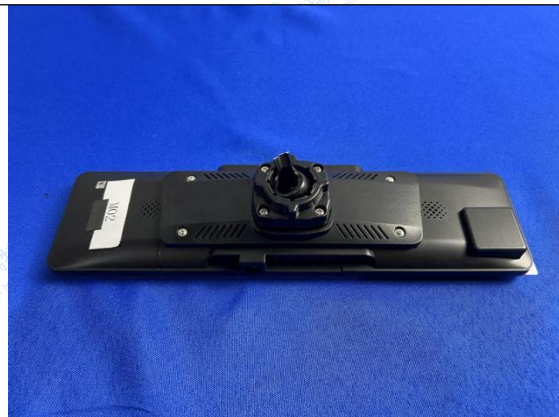
Fig.9 Appearance inspection after test

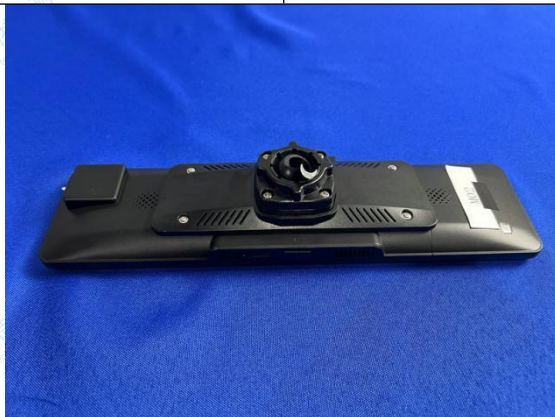
Fig.10 Appearance inspection after test
