## TEST REPORT

| <p align="center"><b>Report Number</b><br/><b>ORT251224112703-R05Rev1</b></p> | | | | | |
| <b>Sample Name:</b> | <b>Automotive streaming media Mirror、DVR-MIR012、DVR-MIR012-BO</b> | | <b>Applicant:</b> | <b>WATEX CO.,LTD.</b> | |
| <b>Test Item:</b> | <b>Impact test</b> | | | | |

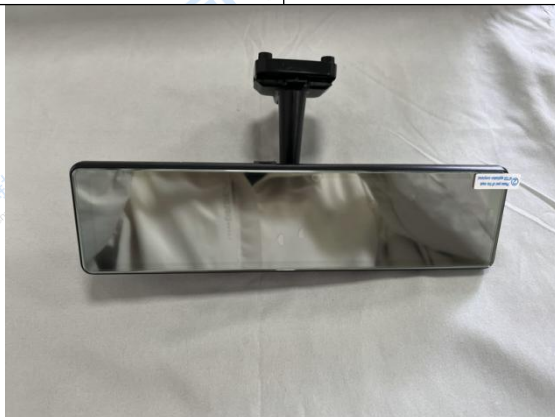
Fig.1 Appearance inspection before test

Fig.2 Appearance inspection before test

Fig.3 Appearance inspection before test

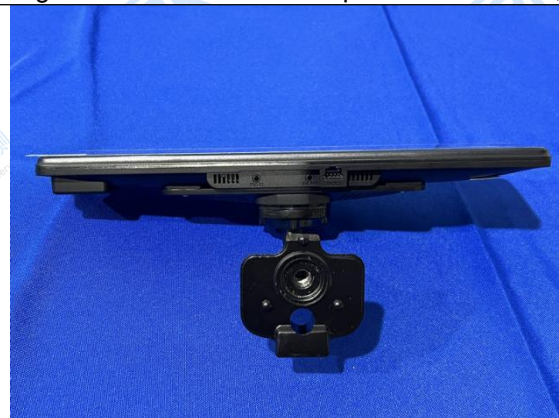
| Sample No. | Inspection after test | Conclusion |
|---|---|---|
| ORT251224112703-SS5/16 | <p>1.Frontal Impact:The streaming media mirror is in good condition.</p> <p>2.45° angle Impact:The streaming media mirror is in good condition.</p> <p>The test shall be considered satisfactory if the reflecting surface is made of safety glass and if, in the event of breakage, the fragments remain adherent to the housing or to a surface firmly fixed to it.</p> <p>Partial separation of the glass is acceptable provided that the separation between the edges of any crack does not exceed 2.5 mm.</p> <p>Detachment of small splinters at the point of impact is permitted.</p> | PASS |

Fig.6 Appearance inspection after test

Fig.7 Appearance inspection after test

Fig.8 Appearance inspection after test
