# Shenzhen ORT Technical Services Co., Ltd.

## TEST REPORT

| <p align="center"><b>Report Number</b><br/><b>ORT251224112703-R07</b></p> | | | | | |
| <b>Test Item:</b> | <b>Impact test</b> | | | | |

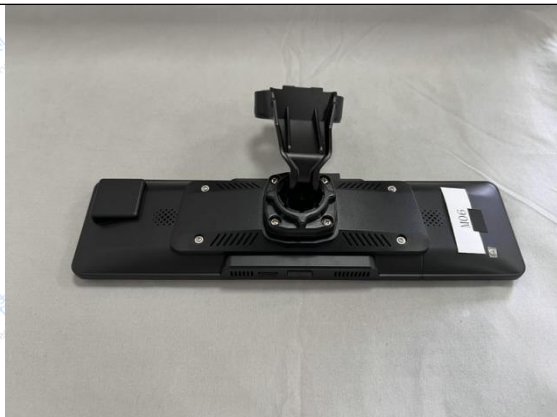
Fig.1 Appearance inspection before test

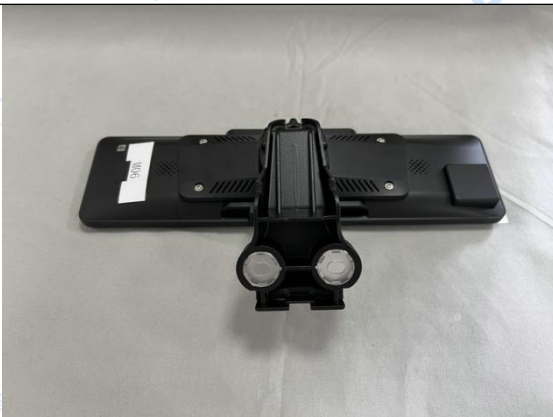
Fig.2 Appearance inspection before test

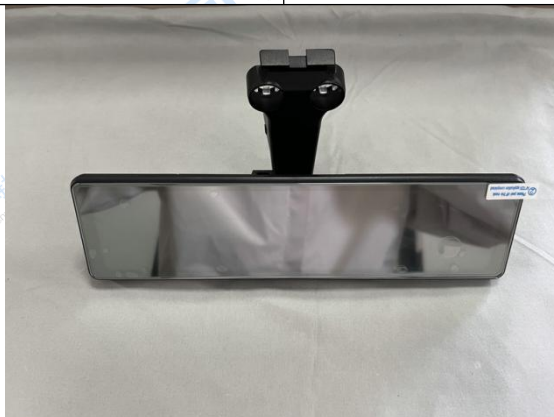
Fig.3 Appearance inspection before test

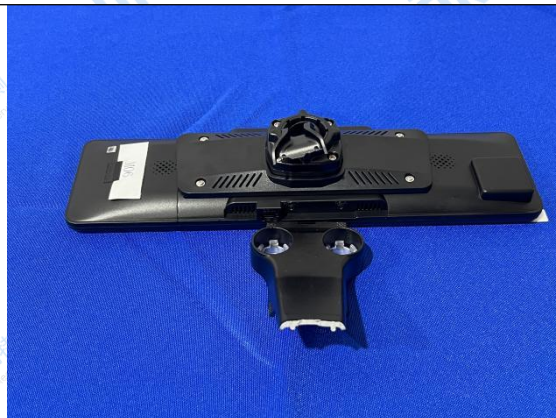
Fig.6 Appearance inspection after test (The front impact bracket has fractured.)

| Sample No. | Inspection after test | Conclusion |
|---|---|---|
| ORT251224112703-SS7/16 | <p>1.Frontal Impact:Impact on the support resulted in fracture.</p> <p>2.45° angle Impact:The streaming media mirror is in good condition.</p> <p>The test shall be considered satisfactory if the reflecting surface is made of safety glass and if, in the event of breakage, the fragments remain adherent to the housing or to a surface firmly fixed to it.</p> <p>Partial separation of the glass is acceptable provided that the separation between the edges of any crack does not exceed 2.5 mm.</p> <p>Detachment of small splinters at the point of impact is permitted.</p> | PASS |

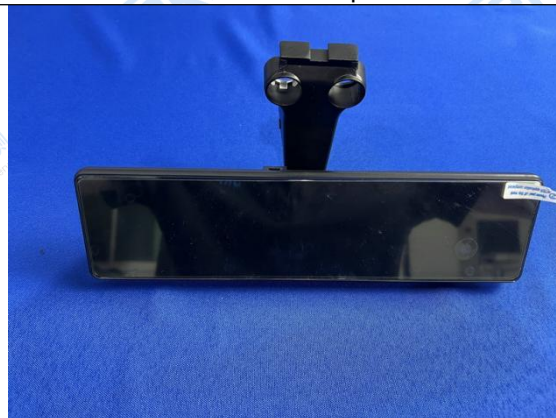
Fig.7 Appearance inspection after test

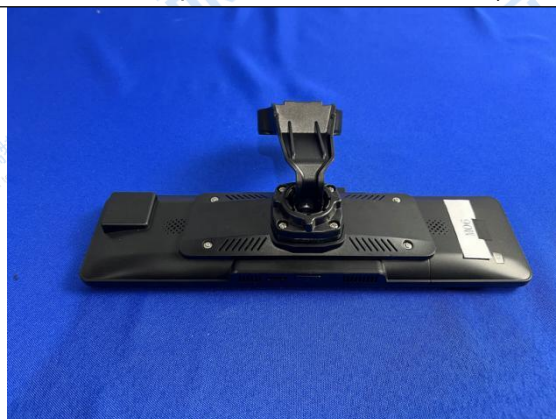
Fig.8 Appearance inspection after test

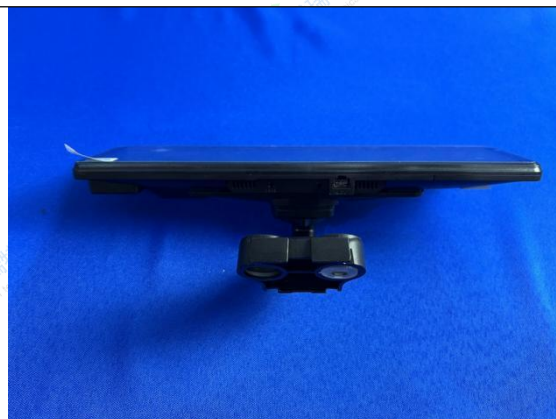
Fig.9 Appearance inspection after test
