## TEST REPORT

| <p align="center"><b>Report Number</b><br/><b>ORT251224112703-R09</b></p> | | | | | |
| <b>Sample Name:</b> | <b>Automotive streaming media Mirror、DVR-MIR010</b> | | <b>Applicant:</b> | <b>WATEX CO.,LTD.</b> | |
| <b>Test Item:</b> | <b>Impact test</b> | | | | |

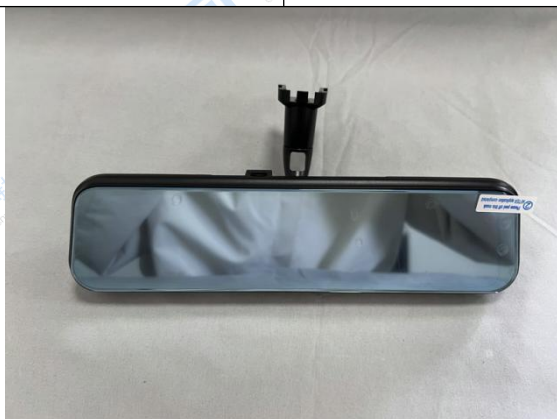
Fig.1 Appearance inspection before test

Fig.2 Appearance inspection before test

Fig.3 Appearance inspection before test

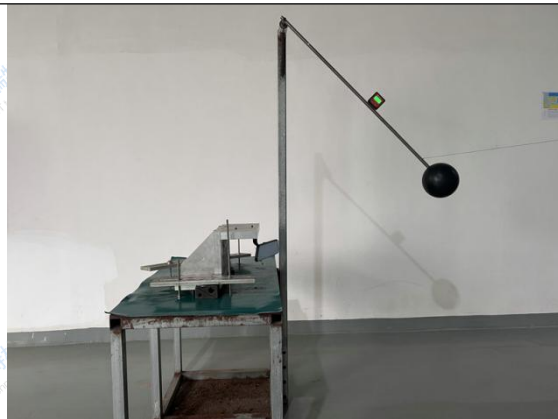
1.3.1 Frontal Impact: The ball head hits the reflective surface.

1.3.2 45° angle Impact: The reflective surface of the lens should form an angle of 45° with the original motion direction of the point on the sphere of the collision point, the collision direction should be towards the reflective surface, and the collision point should be the horizontal plane of the center of the lens reflective surface of the protective cover of the lens, which should pass through the edge.

Fig.4 Test setup

Fig.5 Test setup

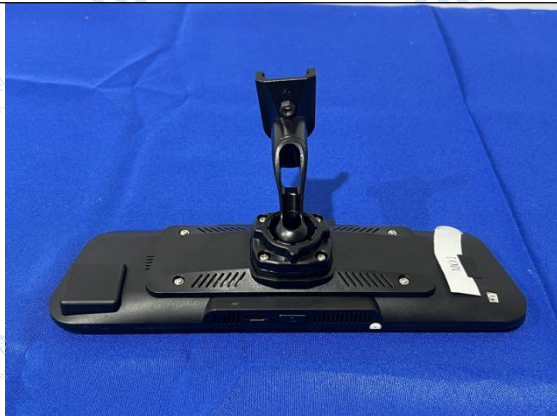
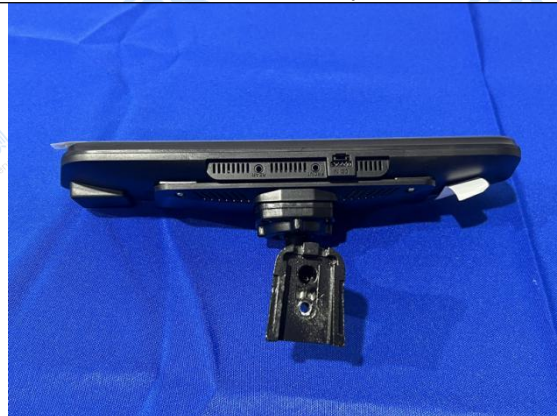
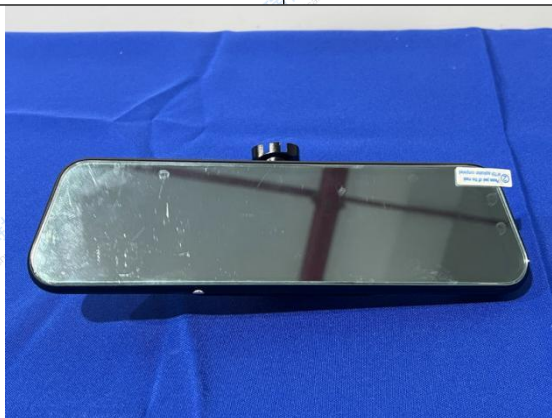
| Sample No. | Inspection after test | Conclusion |
|---|---|---|
| ORT251224112703-SS9/16 | <p>1.Frontal Impact:The streaming media mirror is in good condition.</p> <p>2.45° angle Impact:The streaming media mirror is in good condition.</p> <p>The test shall be considered satisfactory if the reflecting surface is made of safety glass and if, in the event of breakage, the fragments remain adherent to the housing or to a surface firmly fixed to it.</p> <p>Partial separation of the glass is acceptable provided that the separation between the edges of any crack does not exceed 2.5 mm.</p> <p>Detachment of small splinters at the point of impact is permitted.</p> | PASS |

Fig.6 Appearance inspection after test

Fig.7 Appearance inspection after test

Fig.8 Appearance inspection after test
