# Shenzhen ORT Technical Services Co., Ltd.

## TEST REPORT

| <p align="center"><b>Report Number</b><br/><b>ORT251224112703-R09Rev2</b></p> | | | | | |
| <b>Sample Name:</b> | Automotive streaming media Mirror、DVR-MIR010、DVR-MI-10Pro、DVR-MIR010-BO | | <b>Applicant:</b> | WATEX CO.,LTD. | |

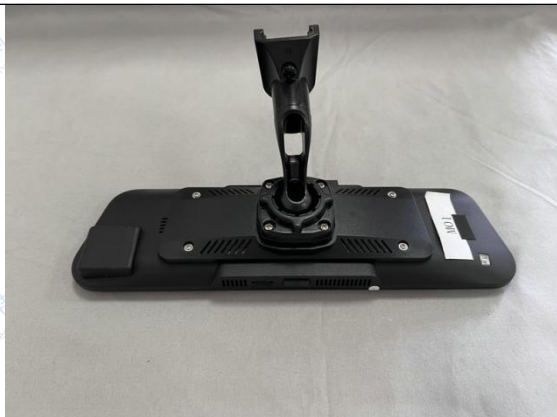
Fig.1 Appearance inspection before test

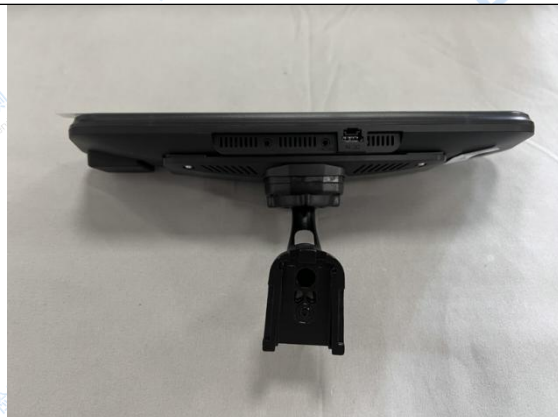
Fig.2 Appearance inspection before test

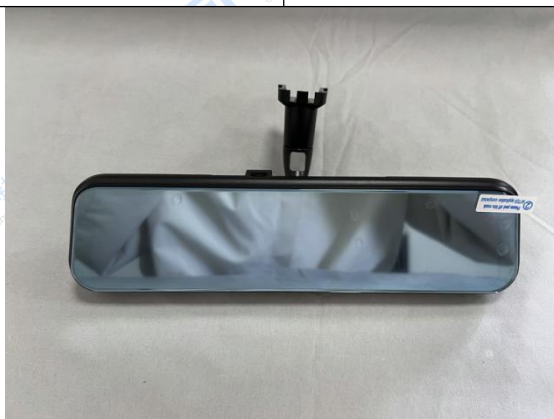
Fig.3 Appearance inspection before test

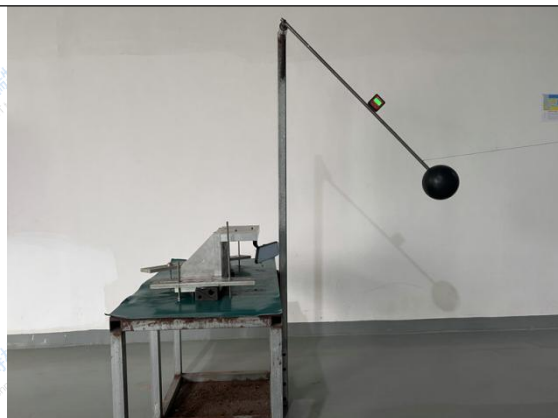
Fig.5 Test setup

1.3.1 Frontal Impact: The ball head hits the reflective surface.

1.3.2 45° angle Impact: The reflective surface of the lens should form an angle of 45° with the original motion direction of the point on the sphere of the collision point, the collision direction should be towards the reflective surface, and the collision point should be the horizontal plane of the center of the lens reflective surface of the protective cover of the lens, which should pass through the edge.

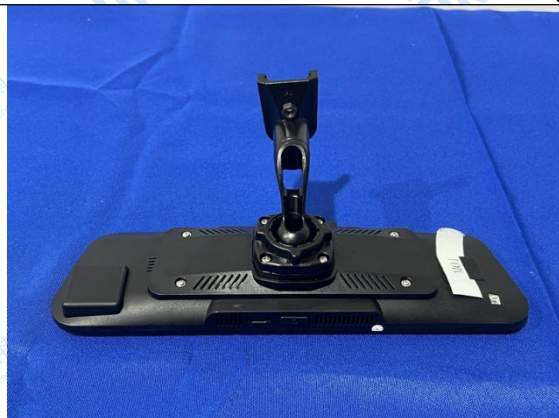
Fig.6 Appearance inspection after test

| Sample No. | Inspection after test | Conclusion |
|---|---|---|
| ORT251224112703-SS9/16 | <p>1.Frontal Impact:The streaming media mirror is in good condition.</p> <p>2.45° angle Impact:The streaming media mirror is in good condition.</p> <p>The test shall be considered satisfactory if the reflecting surface is made of safety glass and if, in the event of breakage, the fragments remain adherent to the housing or to a surface firmly fixed to it.</p> <p>Partial separation of the glass is acceptable provided that the separation between the edges of any crack does not exceed 2.5 mm.</p> <p>Detachment of small splinters at the point of impact is permitted.</p> | PASS |

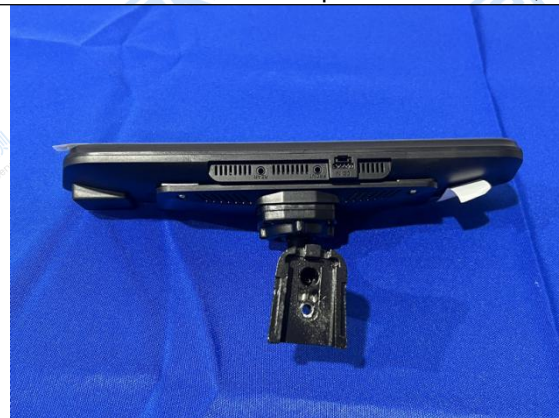
Fig.7 Appearance inspection after test

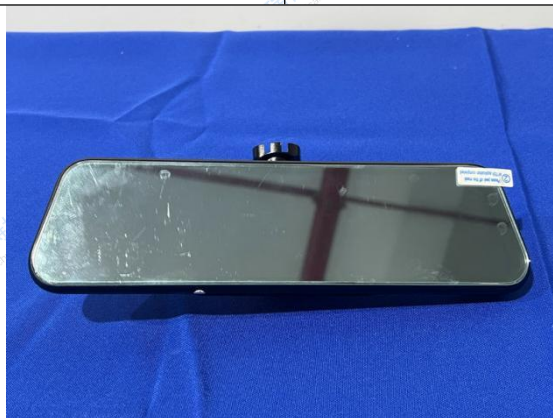
Fig.8 Appearance inspection after test
