# Shenzhen ORT Technical Services Co., Ltd.

## TEST REPORT

| <p align="center"><b>Report Number</b><br/><b>ORT251224112703-R14Rev1</b></p> | | | | | |
| <b>Sample Name:</b> | <b>Automotive streaming media Mirror、DVR-MIR010、DVR-MIR010-BO</b> | | <b>Applicant:</b> | <b>WATEX CO.,LTD.</b> | |

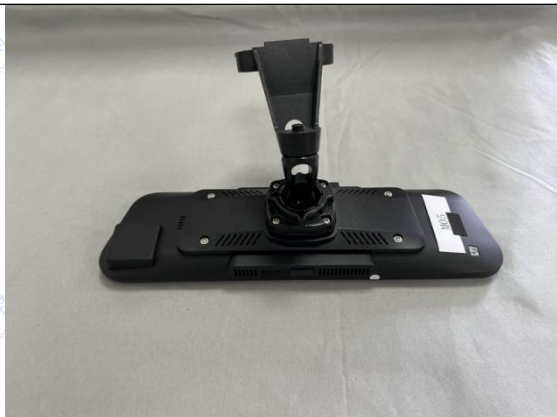
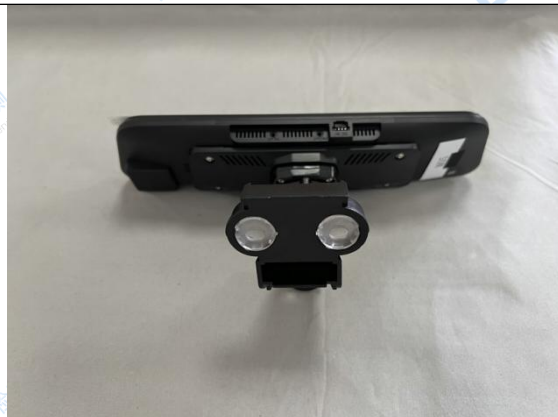
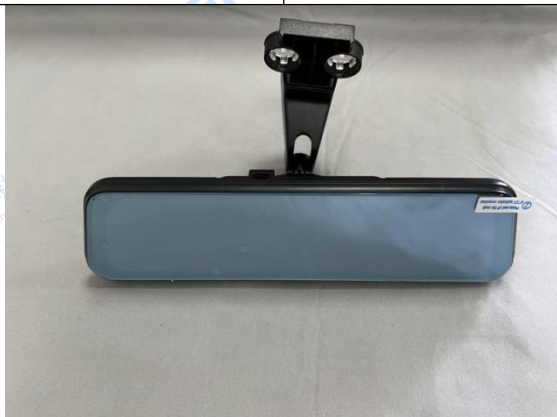
Fig.1 Appearance inspection before test

Fig.2 Appearance inspection before test

Fig.3 Appearance inspection before test

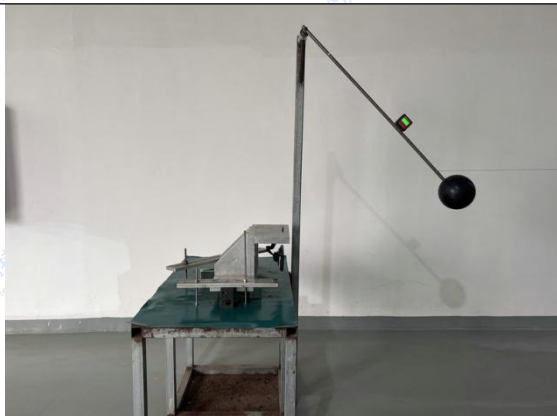
1.4.1 Frontal Impact: The ball head hits the reflective surface.

1.4.2 45° angle Impact: The reflective surface of the lens should form an angle of 45° with the original motion direction of the point on the sphere of the collision point, the collision direction should be towards the reflective surface, and the collision point should be the horizontal plane of the center of the lens reflective surface of the protective cover of the lens, which should pass through the edge.

Fig.4 Test setup

Fig.5 Test setup

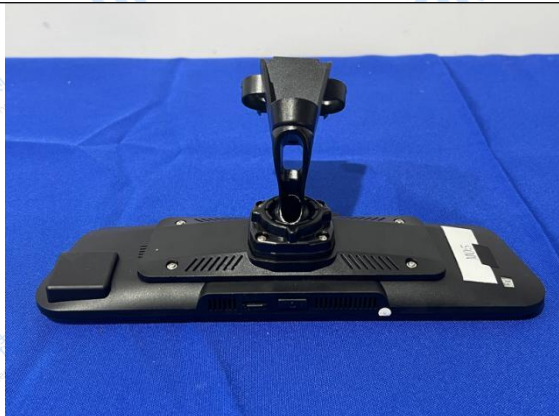
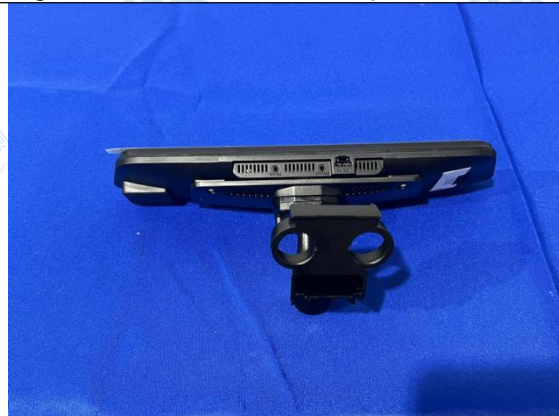
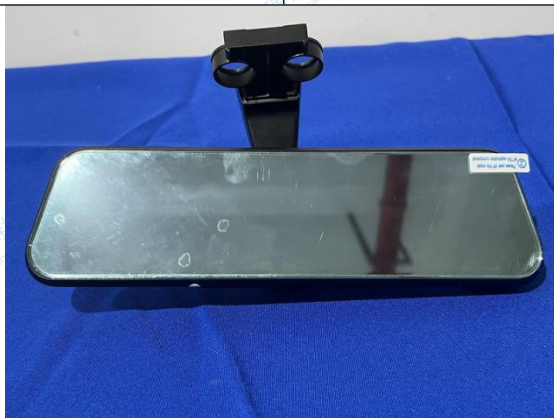
| Sample No. | Inspection after test | Conclusion |
|---|---|---|
| ORT251224112703-SS14/16 | <p>1.Frontal Impact:The streaming media mirror is in good condition.</p> <p>2.45° angle Impact:The streaming media mirror is in good condition.</p> <p>The test shall be considered satisfactory if the reflecting surface is made of safety glass and if, in the event of breakage, the fragments remain adherent to the housing or to a surface firmly fixed to it.</p> <p>Partial separation of the glass is acceptable provided that the separation between the edges of any crack does not exceed 2.5 mm.</p> <p>Detachment of small splinters at the point of impact is permitted.</p> | PASS |

Fig.6 Appearance inspection after test

Fig.7 Appearance inspection after test

Fig.8 Appearance inspection after test
