Shenzhen ORT Technical Services Co., Ltd.

TEST REPORT

Report Number					
ORT251224112703-R16					
Sample Name:	Automotive streaming media Mirror、DVR-MIR010			Applicant:	WATEX CO .,LTD.
Model:	WTX-M07-010			Address:	162-13, Godo-cho, Ota-city, Gunma, Japan 373-0004
Spec:	/			Vendor or Supplier:	/
Brand:	WATEX			Address:	/
Sample Quantity:	1 Pc			Manufacturer:	Shenzhen Daza Innovation Technology Company Limited
Specimen Source:	Submitted by applicant			Address:	/
Received Date:	Jan. 05, 2026	Detection Date:	Jan. 06, 2026~ Jan. 15, 2026	Report Date:	Jan. 19, 2026
Test Requirement:	According to ECE R46 6.3.2				
Test Item:	Impact test				
Decision Rules:	<p>The test shall be considered satisfactory if the reflecting surface is made of safety glass and if, in the event of breakage, the fragments remain adherent to the housing or to a surface firmly fixed to it.</p> <p>Partial separation of the glass is acceptable provided that the separation between the edges of any crack does not exceed 2.5 mm.</p> <p>Detachment of small splinters at the point of impact is permitted.</p>

1 Test Item: Impact test

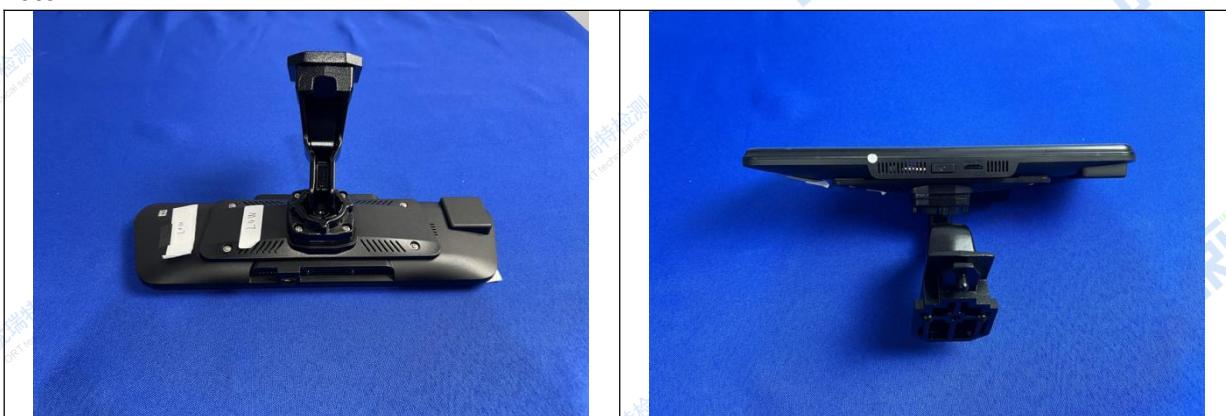
Fig.1 Appearance inspection before test

Fig.2 Appearance inspection before test

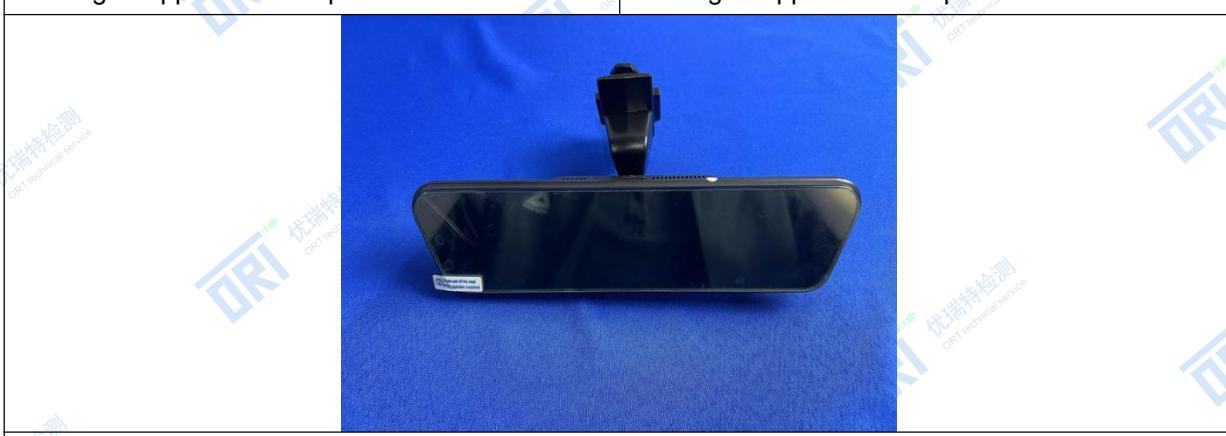
Fig.3 Appearance inspection before test

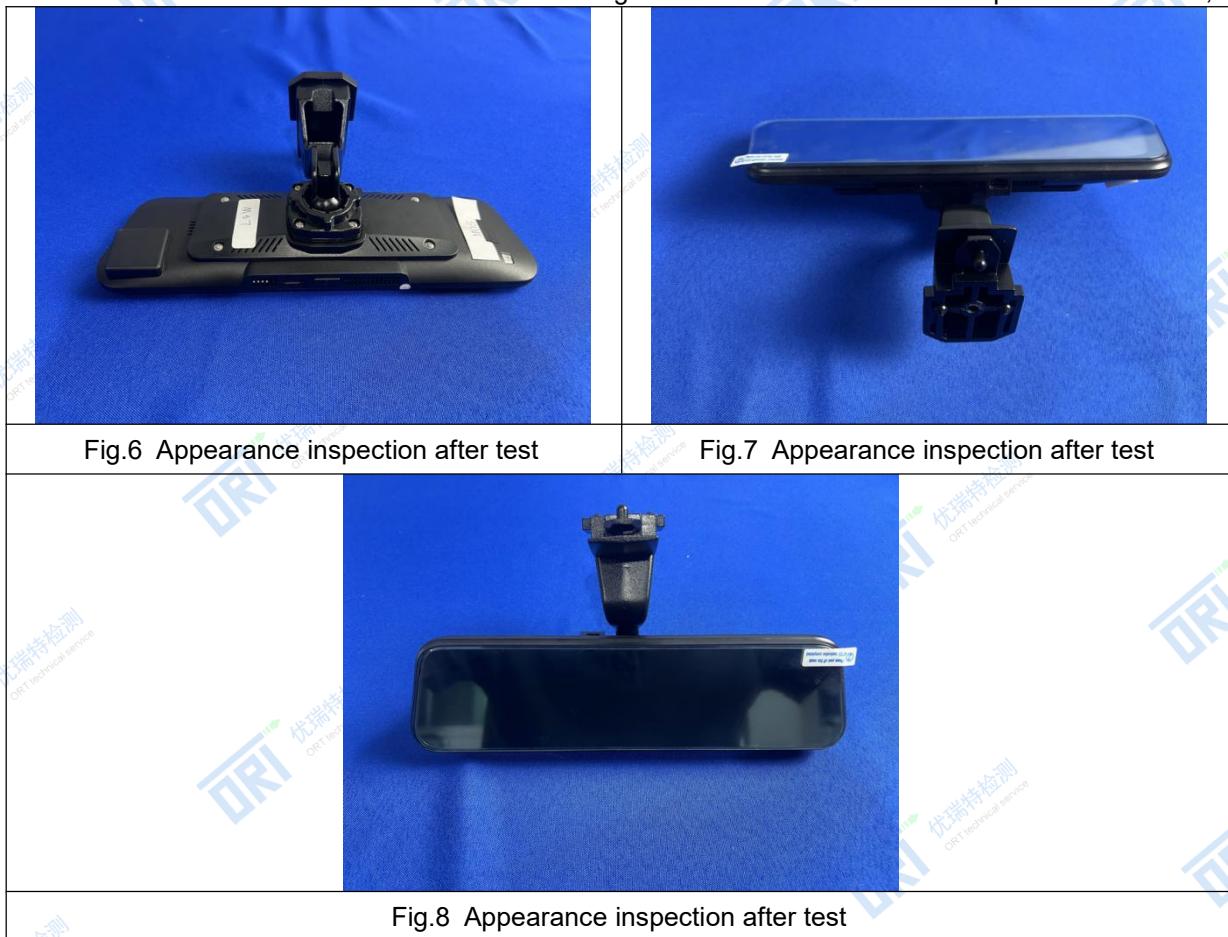
Sample No.	Inspection after test	Conclusion
ORT251224112703-SS16/16	<p>1. Frontal Impact: The streaming media mirror is in good condition.</p> <p>2. 45° angle Impact: The streaming media mirror is in good condition.</p> <p>The test shall be considered satisfactory if the reflecting surface is made of safety glass and if, in the event of breakage, the fragments remain adherent to the housing or to a surface firmly fixed to it.</p> <p>Partial separation of the glass is acceptable provided that the separation between the edges of any crack does not exceed 2.5 mm.</p> <p>Detachment of small splinters at the point of impact is permitted.</p>	PASS

Fig.6 Appearance inspection after test

Fig.7 Appearance inspection after test

Fig.8 Appearance inspection after test
