## TEST REPORT

| <p align="center"><b>Report Number</b><br/><b>ORT251224112703-R16Rev1</b></p> | | | | | |
| <b>Sample Name:</b> | <b>Automotive streaming media Mirror、DVR-MIR010、DVR-MIR010-BO</b> | | <b>Applicant:</b> | <b>WATEX CO.,LTD.</b> | |
| <b>Test Item:</b> | <b>Impact test</b> | | | | |

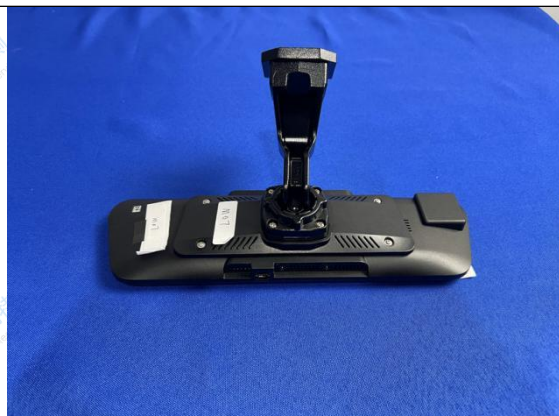
Fig.1 Appearance inspection before test

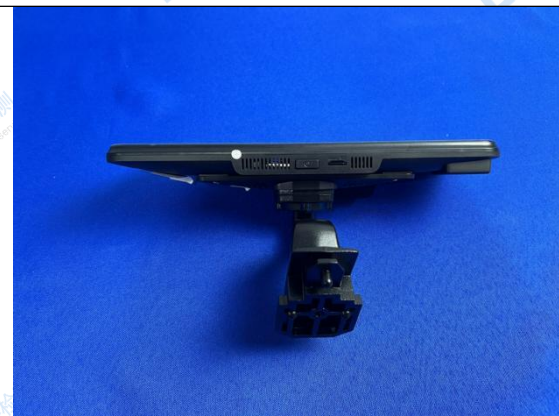
Fig.2 Appearance inspection before test

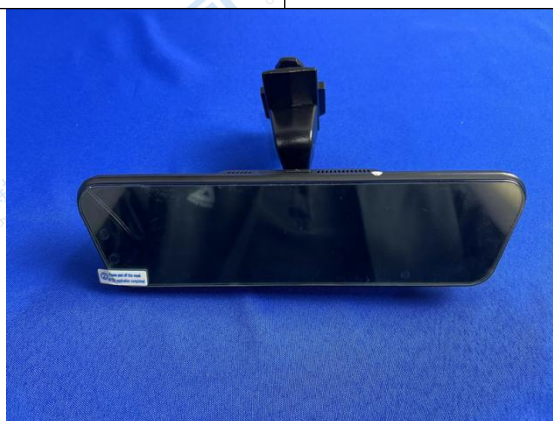
Fig.3 Appearance inspection before test

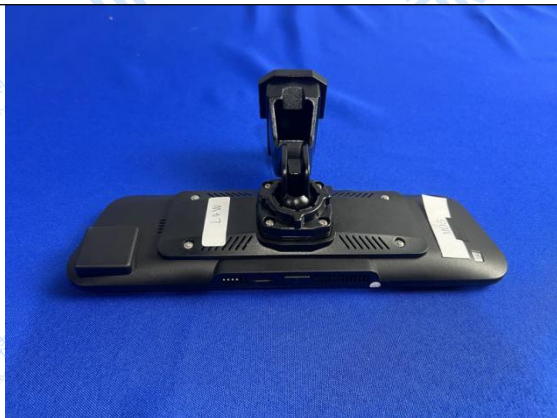
Fig.6 Appearance inspection after test

| Sample No. | Inspection after test | Conclusion |
|---|---|---|
| ORT251224112703-SS16/16 | <p>1.Frontal Impact:The streaming media mirror is in good condition.</p> <p>2.45° angle Impact:The streaming media mirror is in good condition.</p> <p>The test shall be considered satisfactory if the reflecting surface is made of safety glass and if, in the event of breakage, the fragments remain adherent to the housing or to a surface firmly fixed to it.</p> <p>Partial separation of the glass is acceptable provided that the separation between the edges of any crack does not exceed 2.5 mm.</p> <p>Detachment of small splinters at the point of impact is permitted.</p> | PASS |

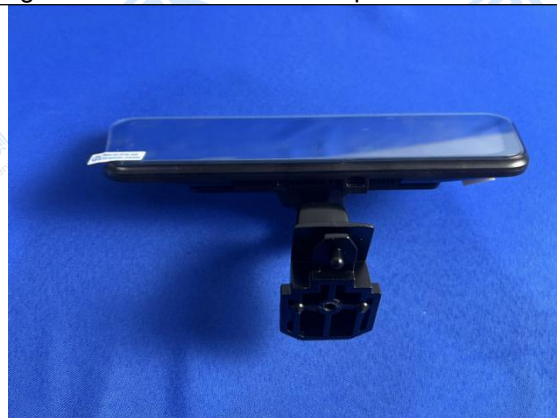
Fig.7 Appearance inspection after test

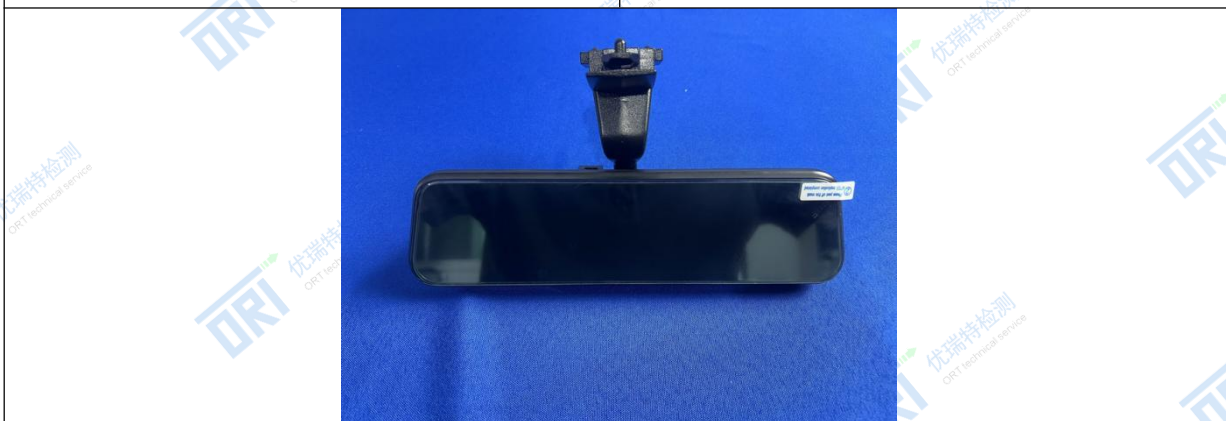
Fig.8 Appearance inspection after test
