## TEST REPORT

| Report Number<br>ORT260612112701-R01 | | | | | |
| Sample Name: | DVR-MIR010、<br>DVR-MIR010-BO | | Applicant: | WATEX CO.,LTD. | |
| Test Item: | Impact Test | | | | |

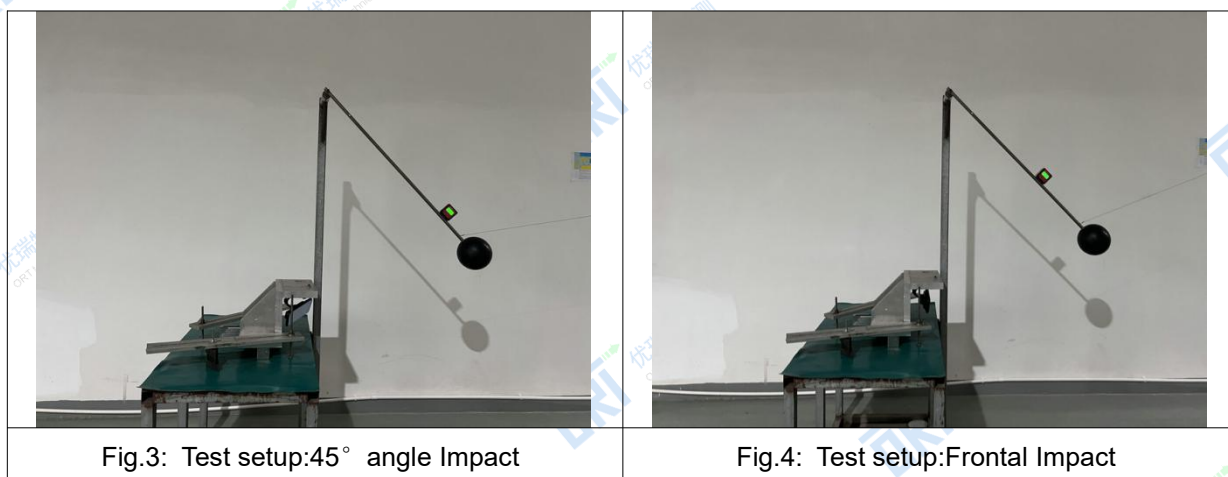
#### Test Item 1: Impact Test

1.3.1 Frontal Impact: The ball head hits the reflective surface.

1.3.2 45° angle Impact: The reflective surface of the lens should form an angle of 45° with the original motion direction of the point on the sphere of the collision point, the collision direction should be towards the reflective surface, and the collision point should be the horizontal plane of the center of the lens reflective surface of the protective cover of the lens, which should pass through the edge.

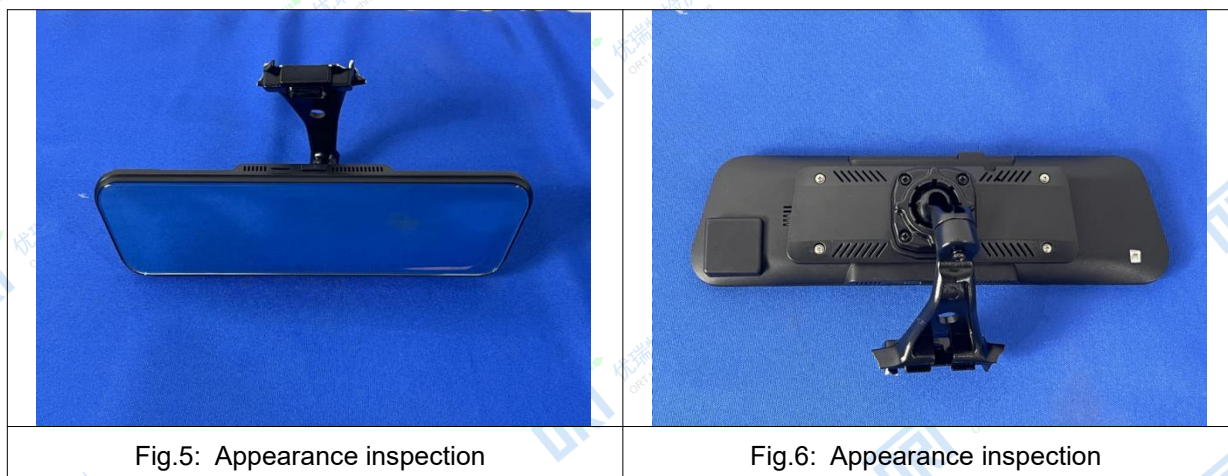
#### Post-test:

| No. | Test Record | Test Item | Sample No. | Sample Test Results | Test Conclusion |
|---|---|---|---|---|---|
| 1 | Page 3 | Impact Test | SS1/1 | 1 Frontal Impact:The streaming media mirror is intact, but the stand is broken.<br>2 45° angle Impact:The streaming media mirror is in good condition. | PASS |
